Walking the Line uncovered more and more temporary repairs

What the public Inquiry found on Brent Bravo

**Shell Expro
Platform Safety Management Review (PSMR)
A Briefing Note (20/10/99)**

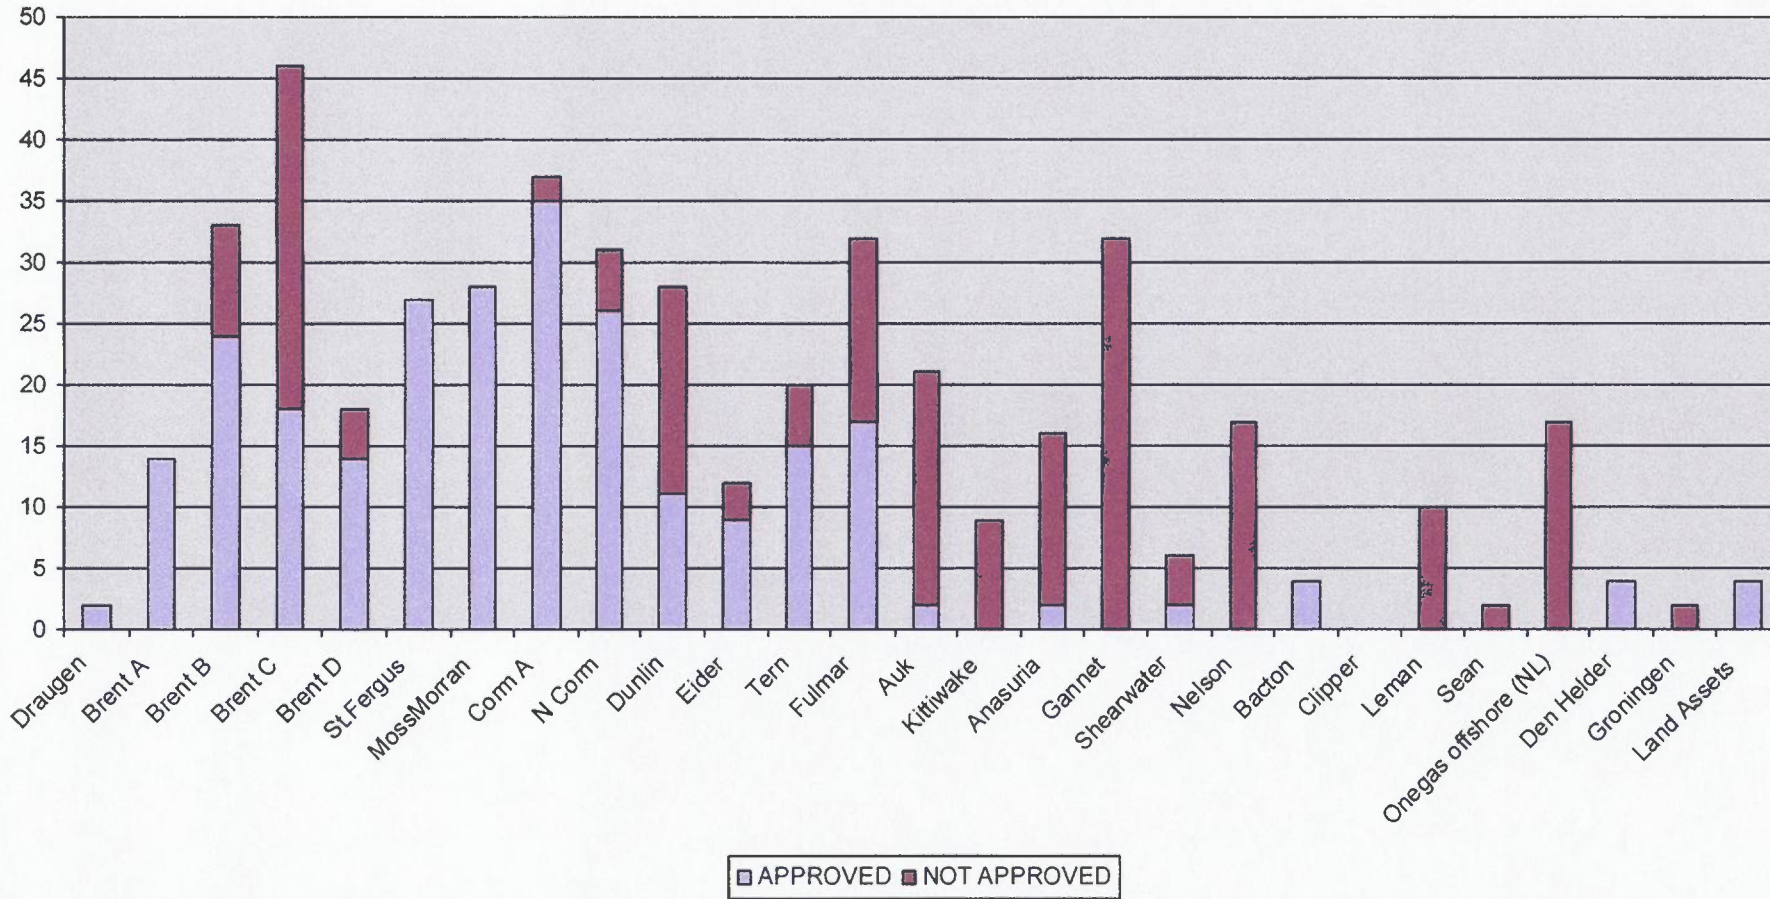
OVERVIEW OF TEMPORARY REPAIRS

What Directors were told about temporary repair and patches on 22nd October 1999, by their Audit team

Extract from a viewgraph used at the management presentation of the Audit findings to the Shell Expro Leadership Team including the Oil and Gas Director at Tullus on 22nd October 1999

In our ageing assets there is increasing use of temporary clamps, due to pipe-work reaching minimum allowable wall thickness

Our corrosion management data is out of date, so who has overall responsibility for this within our business?
